DEPARTMENT OF THE ARMY
UNITED STATES ARMY AVIATION TEST BOARD
Fort Rucker, Alabama 36360

SUBJECT: Letter Report, Product Improvement Test of UH-1D Main
Rotor Grip Seals, RDT&E Project No.
USATECOM Project No. 4-5-0151-10

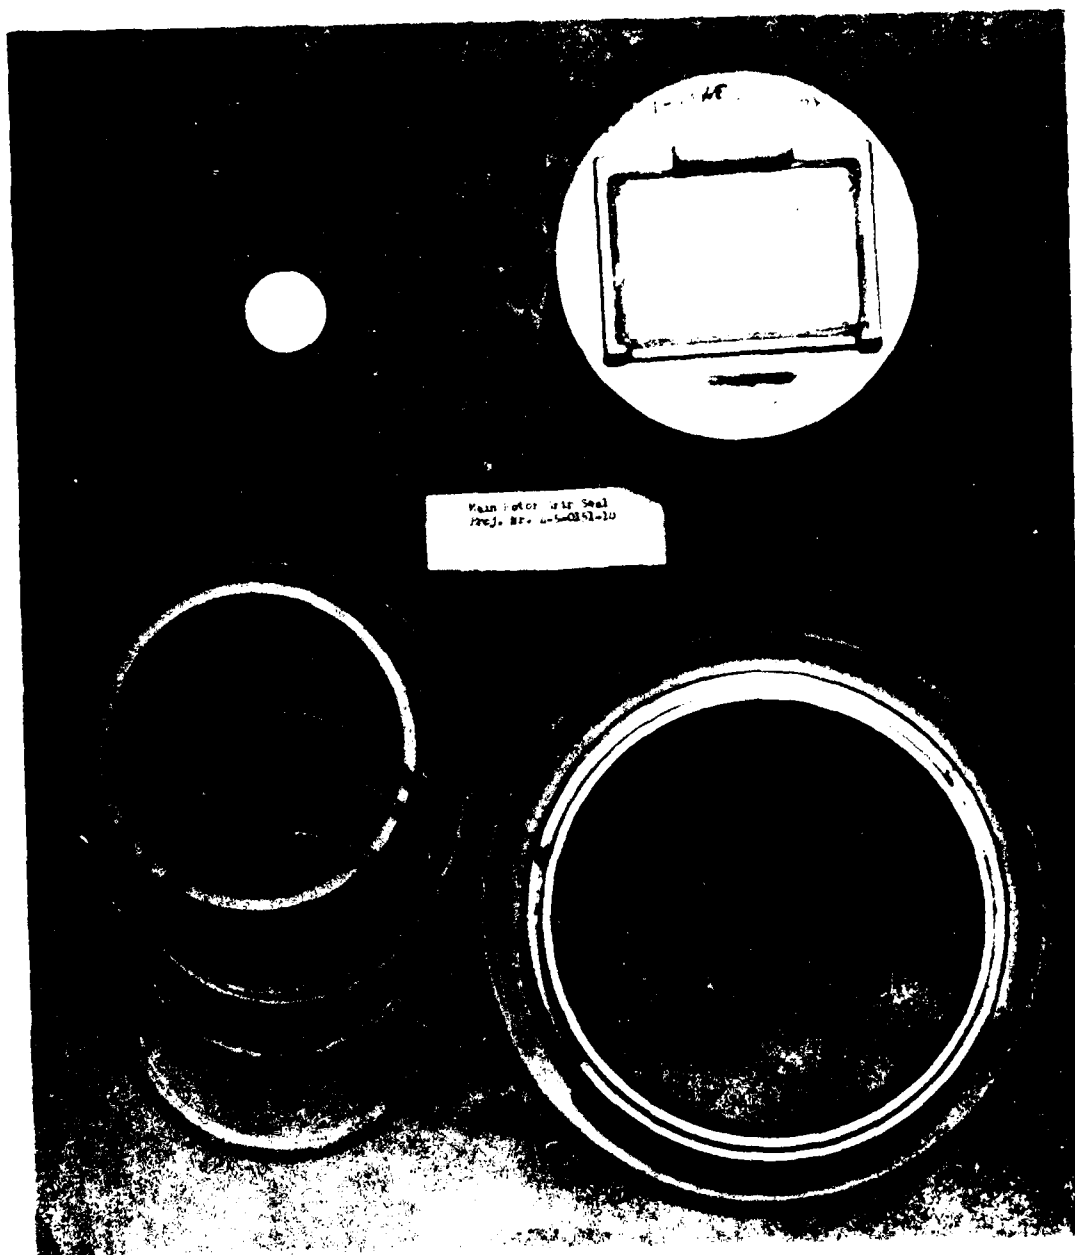
One side of the modified main rotor hub, P/N 204-012-101-1, contains a P/N MS29561-240 "O" ring on the inboard fitting, a P/N MS29561-237 "O" ring on the outboard fitting, aluminum caps to the strap pins, and a radius ring containing a rubber shield to protect the grip seal. The other side of this hub was the same as a standard, 48-foot rotor, UH-1D hub, P/N 204-012-101. (See attached photograph.)

a. The test seals completed 576.5 hours operating time without any leakage or difficulties.

Modified Main Rotor Grip Seal

- a. The production main rotor hub incorporate the modified seals.
- b. An MWO be initiated in accordance with ECP UH-1B/D/E/F-236 at the earliest possible date for incorporation at the next scheduled or unscheduled seal change.
